Case report

Break in the lag: A unique mode of failure of TFNA® lag screw in an intertrochanteric fracture non-union

We describe a case of a 91-year-old lady presenting with cephalic lag screw break through the fenestrations of a Trochanteric Fixation Nail -Advanced (TFNA, DePuy-Synthes®) associated with intertrochanteric fracture non-union, following an unwitnessed ground level fall. This was 11 months after sustaining a proximal femur AO/OTA 31-A2.2 fracture for which she underwent TFNA fixation at a different hospital. Subsequently she underwent broken implant extraction and salvage total hip replacement with bone grafting and made a successful recovery.

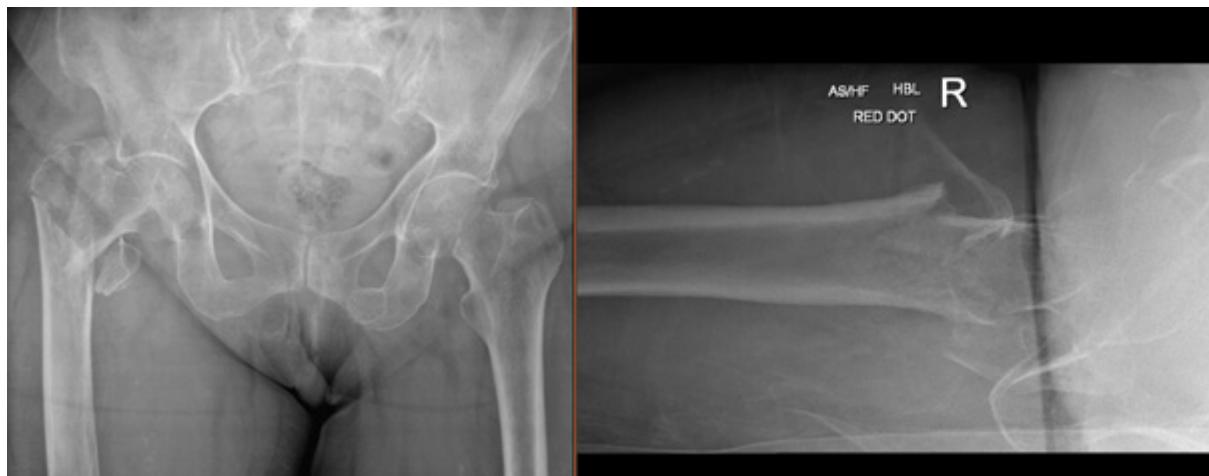
11 months back she sustained an intertrochanteric fracture of the Right femur (AO/OTA 31-A2.2) (**Fig 2**) fracture of the femur extending to just below the lesser trochanter following a fall from standing height and underwent closed reduction and long TFNA fixation at a different hospital. On reviewing the intraoperative images (**Fig 3**) and notes, it was noted that on account of a pre-existing distal femur locking plate (for an old united distal femur fracture) the surgeons were unable to fix distal locking screws through the nail due to plate position. This was concluded with only proximal lag screw abandoning distal fixation, to avoid further complications from pro-

Figure 2: X-rays of the initial Intertrochanteric fracture of the Right femur (AP and lateral views).

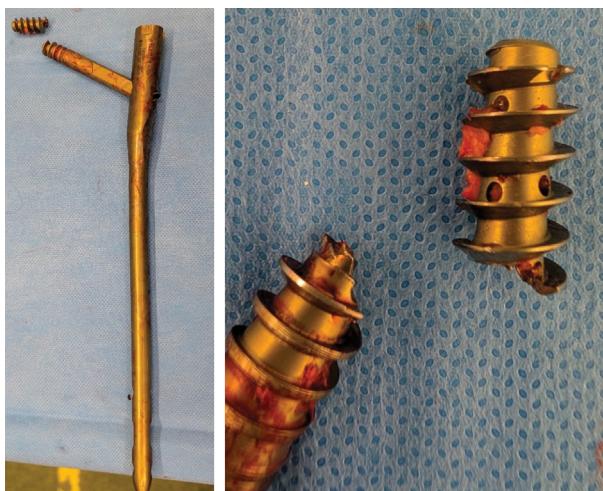
Following a local multidisciplinary discussion involving hip surgeons, orthogeriatric medical team, patient and family members, she underwent a revision surgery for removal of the broken implant, a dual mobility total hip replacement and bone grafting for the acetabular defect (**Fig 4**). Inspection of the explanted hardware confirmed the unusual failure pattern (**Fig 5**) through the threaded region.

Figure 5: Explanted implant showing break through the thread fenestrations.

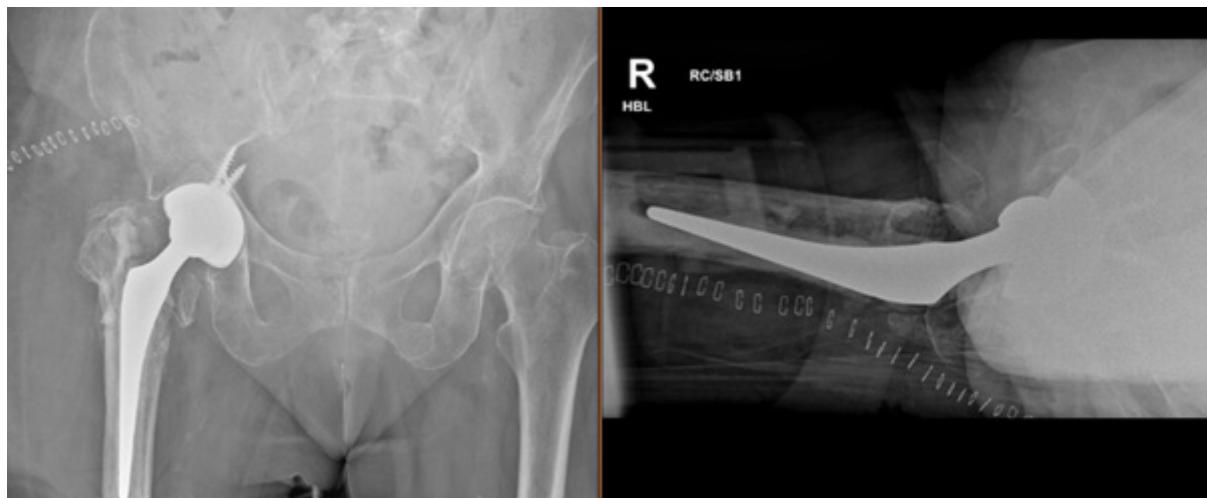
Figure 7: AP and lateral radiographs following revision dual mobility total hip replacement

In this patient, a salvage dual mobility total hip replacement was done (**fig 7**) with an uncemented cup and a cemented stem after explantation of the nail and broken screw. The acetabular defect was deemed to be contained and addressed with bone grafting from freeze-dried femoral head allograft (**fig 4**). The option of dual mobility cup was decided in view of the poor functioning abductors to reduce any chances of dislocation and further morbidity. Criticism could be raised as to why a longer diaphyseal fitting revision stem was not considered that could avoid stress risers and further fractures of the femur shaft. The rationale behind this complex consideration was to avoid a scenario where a long diaphyseal stem could lead to abutment of the already thinned out distal femoral cortices (from the tip of the IM nail) and
